Repair of Earthquake-Damaged Square R/C Columns with Glass Fiber-Reinforced Polymer

Sassan Eshghi¹, Vahid Zanjaniadeh²

Abstract: This paper presents an experimental study on seismic repair of damaged square reinforced concrete columns with poor lap splices, 90-degree hooks and widely spaced transverse bars in plastic hinge regions according to ACI detailing (pre.1971) and (318-02) using GFRP wraps. Three specimens were tested in "as built" condition and retested after they were repaired by glass fiber-reinforced plastic sheets. They were tested under numerous reversed lateral cyclic loading with a constant axial load ratio. FRP composite wraps were used for repairing of concrete columns in critically stressed areas near the column footings. Physical and mechanical properties of composite wraps are described. Seismic performance and ductility of the repaired columns in terms of the hysteretic response are evaluated and compared with those of the original columns. The results indicated that GFRP wraps can be an effective repair measure for poorly confined R/C columns due to short splice length and widely spaced ties with 90-degree anchorage hooks. Both flexural strength and ductili

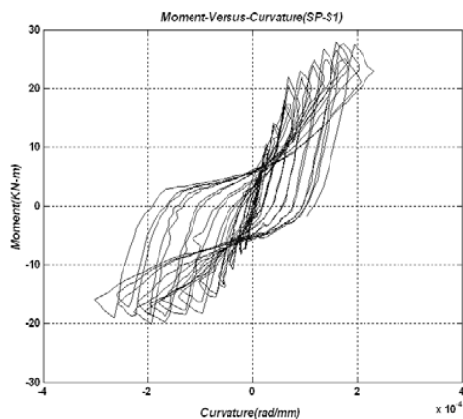
a) SP-S1

During testing of specimen SP-S1 at 1% drift ratio, initial flexural cracks were observed at the column footing interface and at 1.5% drift ratio the same cracks at the column footing

splice length. Some flexural cracks appeared along the splice length during the test but the length and width of these cracks did not increase significantly (Fig.12a).

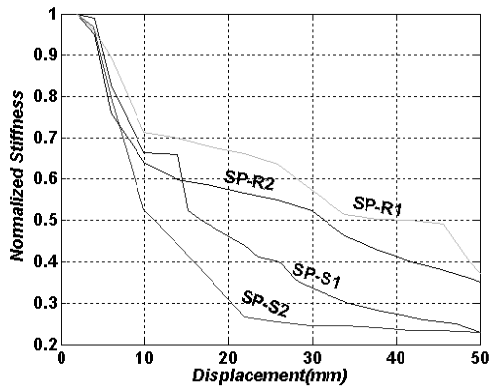
Fig.15 Normalized Stiffness versus Displacement for SP-S1, SP-S2, SP-R1 and SP-R2

Stiffness for each cycle was calculated as the average of the stiffness for the positive and negative directions. Stiffness for each cycle was normalized with respect to the stiffness of the first cycle and was plotted versus the displacement. Stiffness degradation versus column top displacement after normalization is plotted in Fig.15 and Fig.16.

For assessing a repair technique, a single parameter criterion can not be adequate in many cases. Herein, various parameters are employed to evaluate the applied repairing method. SP-S2 and SP-R2 have the same detailing and were subjected to the same axial loading but SP-R2 was repaired with GFRP wraps after testing. Experiments indicated that total cumulative ductility ratio ($N_{\phi t}$), 80% of energy indicator (E_{80}) and total energy indicator (E_t) were increased by 25%,

16% and 14% for SP-R2. These percentages for SP-S3 and SP-R3 were 12%, 113% and 27%. The results of total cumulative ductility and damage indicator for SP-S1, with the same loading condition, were 16% and 50% which were greater than those for SP-S2.
