# Repair of Earthquake-Damaged Square R/C Columns with Glass Fiber-Reinforced Polymer

**Abstract:** This paper presents an experimental study on seismic repair of damaged square reinforced concrete columns with poor lap splices, 90-degree hooks and widely spaced transverse bars in plastic hinge regions according to ACI detailing (pre.1971) and (318-02) using GFRP wraps. Three specimens were tested in "as built" condition and retested after they were repaired by glass fiber-reinforced plastic sheets. They were tested under numerous reversed lateral cyclic loading with a constant axial load ratio. FRP composite wraps were used for repairing of concrete columns in critically stressed areas near the column footings. Physical and mechanical properties of composite wraps are described. Seismic performance and ductility of the repaired columns in terms of the hysteretic response are evaluated and compared with those of the original columns. The results indicated that GFRP wraps can be an effective repair measure for poorly confined R/C columns due to short splice length and widely spaced ties with 90-degree anchorage hooks. Both flexural strength and ductility of repaired columns were im

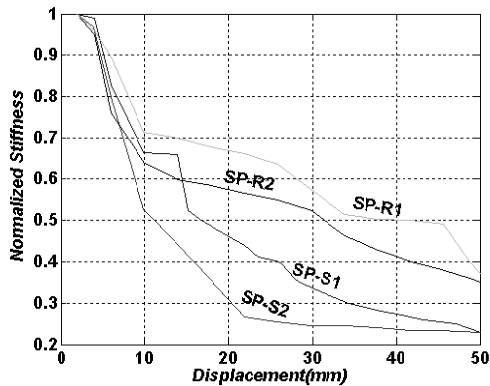
Fig.15 Normalized Stiffness versus Displacement for SP-S1, SP-S2, SP-R1 and SP-R2

Stiffness for each cycle was calculated as the average of the stiffness for the positive and negative directions. Stiffness for each cycle was normalized with respect to the stiffness of the first cycle and was plotted versus the displacement. Stiffness degradation versus column top displacement after normalization is plotted in Fig.15 and Fig.16.

For assessing a repair technique, a single parameter criterion can not be adequate in many cases. Herein, various parameters are employed to evaluate the applied repairing method. SP-S2 and SP-R2 have the same detailing and were subjected to the same axial loading but SP-R2 was repaired with GFRP wraps after testing. Experiments indicated that total cumulative ductility ratio ( $N_{\phi t}$ ), 80% of energy indicator ( $E_{80}$ ) and total energy indicator ( $E_t$ ) were increased by 25%,

16% and 14% for SP-R2. These percentages for SP-S3 and SP-R3 were 12%, 113% and 27%. The results of total cumulative ductility and damage indicator for SP-S1, with the same loading condition, were 16% and 50% which were greater than those for SP-S2.
