Repair of Earthquake-Damaged Square R/C Columns with Glass Fiber-Reinforced Polymer

Abstract: This paper presents an experimental study on seismic repair of damaged square reinforced concrete columns with poor lap splices, 90-degree hooks and widely spaced transverse bars in plastic hinge regions according to ACI detailing (pre.1971) and (318-02) using GFRP wraps. Three specimens were tested in "as built" condition and retested after they were repaired by glass fiber-reinforced plastic sheets. They were tested under numerous reversed lateral cyclic loading with a constant axial load ratio. FRP composite wraps were used for repairing of concrete columns in critically stressed areas near the column footings. Physical and mechanical properties of composite wraps are described. Seismic performance and ductility of the repaired columns in terms of the hysteretic response are evaluated and compared with those of the original columns. The results indicated that GFRP wraps can be an effective repair measure for poorly confined R/C columns due to short splice length and widely spaced ties with 90-degree anchorage hooks. Both flexural strength and ductility of repaired columns were improved

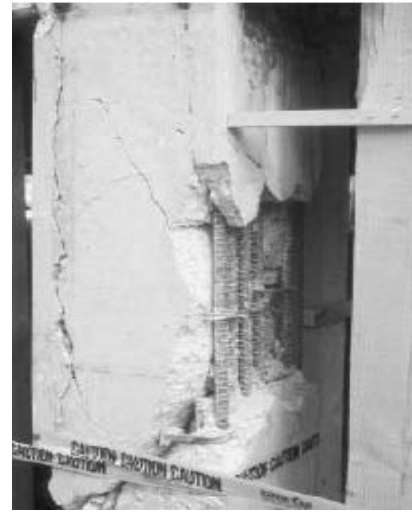
Fig.2 Failure of lap splice due to insufficient splice length and widely spaced ties with 90° hooks (Northridge-1994)

The most common types of non-ductile details are short splice length and wide ties with 90° hooks. These details had led to considerable damages in recent earthquakes. Fig.1 and Fig.2 show two-column damage in Izmit and Northridge earthquakes due to such detailing.

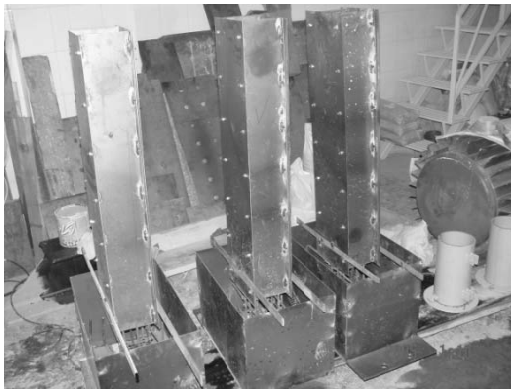
Fig.3 Specimens reinforcing cage in their formworks

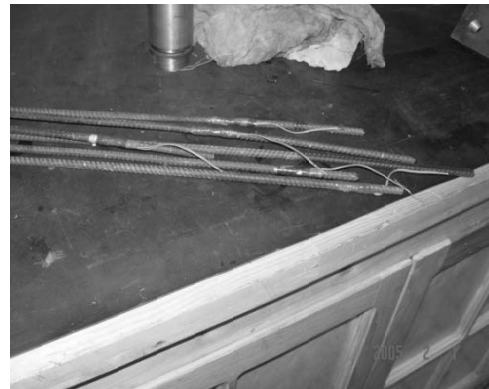
Fig.4 Strain gauges were installed on the bars

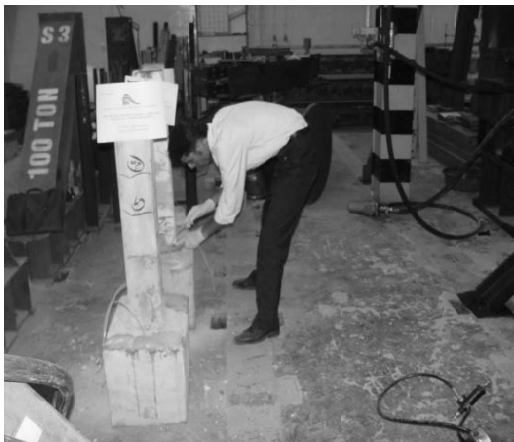
Fig.8 Cleanig surface of the damaged columns

All three specimens in as-built condition were tested and then were repaired by first replacing the loosened concrete with quickset cement then were cleaned with a high pressure gun and completely dried before the vinyl ester was applied to their surfaces (Fig.8). Special measures were taken to ensure that there were no voids between the

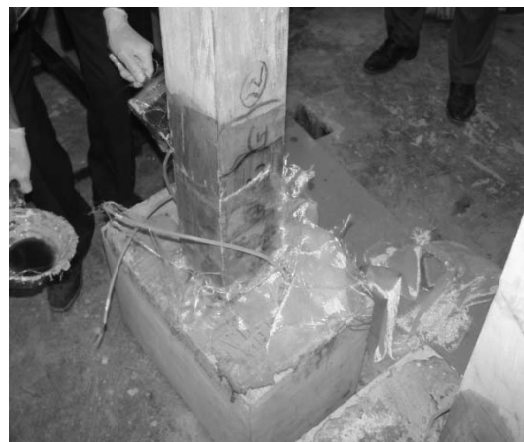
Fig.9 Installation of prefabricated composit sheets

The wrapping of the columns continued to the upper region of the column (Fig.9). All the repaired specimens were cured at least for 7 days to ensure that full strength had obtained before testing.
