# Repair of Earthquake-Damaged Square R/C Columns with Glass Fiber-Reinforced Polymer

**Abstract:** This paper presents an experimental study on seismic repair of damaged square reinforced concrete columns with poor lap splices, 90-degree hooks and widely spaced transverse bars in plastic hinge regions according to ACI detailing (pre.1971) and (318-02) using GFRP wraps. Three specimens were tested in “as built” condition and retested after they were repaired by glass fiber-reinforced plastic sheets. They were tested under numerous reversed lateral cyclic loading with a constant axial load ratio. FRP composite wraps were used for repairing of concrete columns in critically stressed areas near the column footings. Physical and mechanical properties of composite wraps are described. Seismic performance and ductility of the repaired columns in terms of the hysteretic response are evaluated and compared with those of the original columns. The results indicated that GFRP wraps can be an effective repair measure for poorly confined R/C columns due to short splice length and widely spaced ties with 90-degree anchorage hooks. Both flexural strength and ductility of repaired columns were im

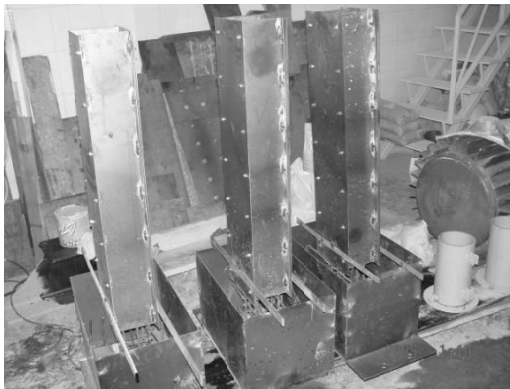
**Fig.3** Specimens reinforcing cage in their formworks

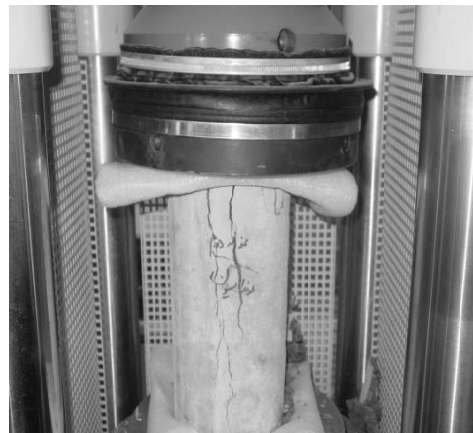
**Fig.6** Cylindrical sample under compression test

0.5. Portland cement, Type 2, was used in this study. The average slump was 120.2-mm. Three 152.5×305-mm (6×12 in) cylindrical samples were tested to obtain the concrete compressive strength (Fig. 6).
