## Experimental and numerical study of strengthened single storey brick building under torsional moment

### Abstract

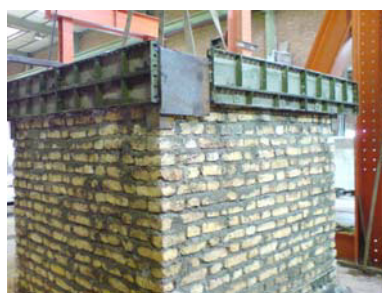
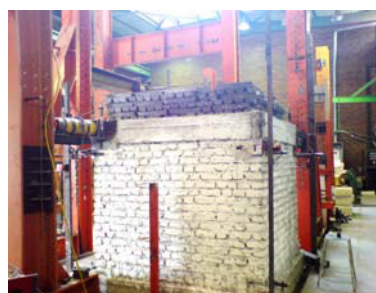
**Fig. 3.** Making Specimen UBB ready for test

a) Integrated first row of Brick walls

b) Construction of foundation and first row with steel wire mesh connected to foundation

c) Reinforcing and concreting of slab and upper tie

d) Instrumented specimen ready for test

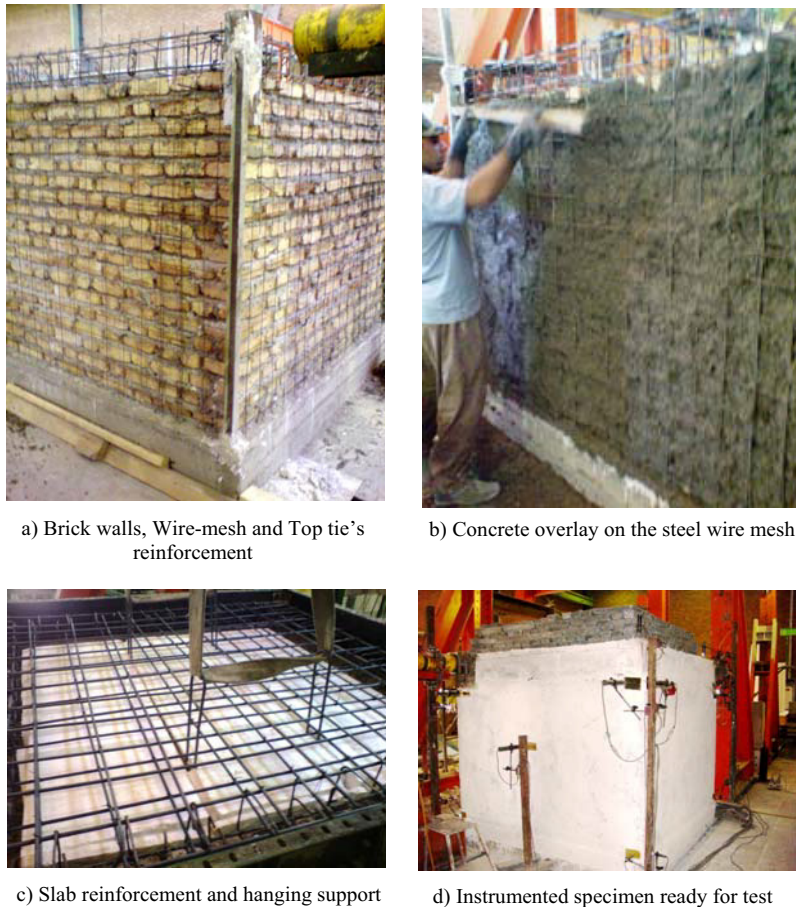
Fig. 4. Making Specimen SUBB ready for test

The second specimen was completely similar to the control specimen and the out surface of its walls were strengthened with concrete overlay reinforced with steel mesh and designated as SUBB. The thickness of concrete overlay was 40mm. Steel mesh of ribless-bar type with diameter of 4mm and spacing of 100 mm were used to reinforce this concrete overlay. This steel wire mesh was attached to the brick wall by  $\phi 6$  anchors 300 mm apart. For the purpose of integrity, it was required to provide additional steel wire mesh into the foundation before concreting. These additional wire meshes were tied to the reinforcement of the concrete overlay around the specimen. To homogenize roof and foundation with walls, an extra row of walls constructed in such a way to be merged with the upper RC tie and with the foundation. In addition, 80mm length of reinforcement inserted into the vertical bonds of the extra row of the walls that was extended into the upper ties. In the lower part, 150 mm extra height of the steel wire mesh was connected to the upper

tie's reinforcement to have uniformity between wall and concrete overlay. Figure 4 illustrates some photos of the construction of this specimen.

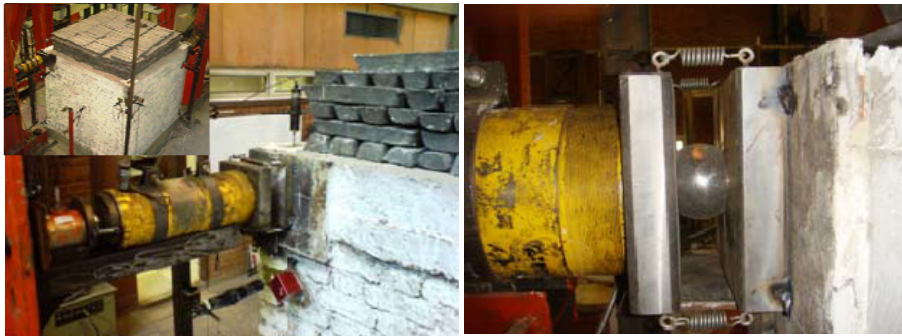
a) Schematic testing setup system

b) Application of loading system

c) Detail of Self controlled applied loading system

Fig. 5. Testing setup, instrumentation and loading system details

Two different systems of gravity and horizontal monotonic loading were applied. The 8 tons subjected gravity load was equal to a double-floored brick building with the dead load and live load of 600 and 200 kg/m<sup>2</sup> respectively. This gravity loading was statically applied by putting lead bullion (each 18.4 kg) on the roof of the specimens. Hydraulic jacks were employed to apply two lateral concentrated loads, which measured through load cells installed behind them. An automatic data acquisition system was used to continuously read applied displacements and measured loads, displacements and strains. In the place where the horizontal loads were applied, two steel plates of 25mm thick were placed during the construction of upper tie for both specimens. To prevent the load path disposition due to torsional movement of specimens, a special devices were designed and constructed. These devices were positioned between hydraulic jacks and specimens as shown in Figure 5.

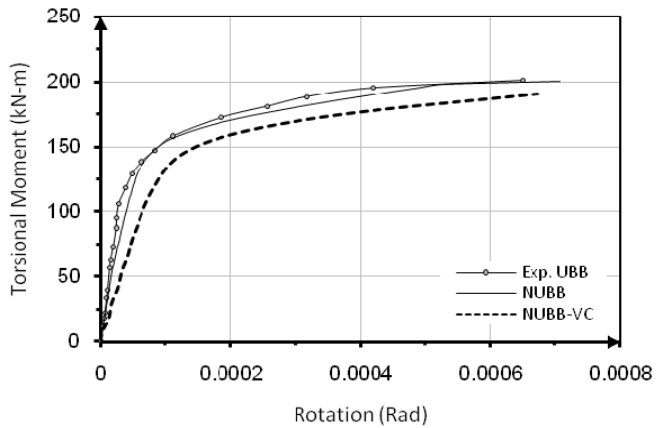
a) Specimen UBBs, Curve

b) Specimen SUBBs, Curve

c) Comparison of Experimental and Numerical T- $\theta$  curves for both buildings

Fig. 10. Experimental and numerical T- $\theta$  curve of both buildings

The numerical torque-twist curve of the specimen is drawn and compared with that of experiment with excellent agreement illustrated if Figure 10-a. The collapse mechanism with diagonal cracking through vertical and horizontal joints and bricks with toe crushing observed in the model and the experimental results. Figures 9-a and 9-b illustrate un-deformed and deformed modeling of this specimen.

SUBB buildings are prepared and shown in Figure 10-a and 10-b. In this, good agreement between the numerical and experimental torque-twist relationship is illustrated. Table 6 gives the torsional moment for different states of behavior and their relevant ratios. The ratio of torsional moment of strengthened specimen to that of unstrengthened specimen for various state of behavior is 2.03, 2.76, 3.77, 3.25, 3.11 and 3.23 respectively and the ratio for elastic torsional rigidity is 1.56. These are good indication of the effect of RC overlay as a simple and rapid strengthening method to be used for

behavior of brick building with vulnerable connection, shown in Figure 10-c. In addition, Table 6 provides the torsional moments for specimens with and without vulnerable connections. As it is seen the torsional capacity of the specimen UBB with respect to specimen NUBB-VC is 23% and 6% higher at cracking and yielding states respectively and almost the same at ultimate state. This is most probably due to the fact that the ultimate strength of both buildings is independent to the wall connections as the torsional cracks are start to widen at this stage with the concentration of shear

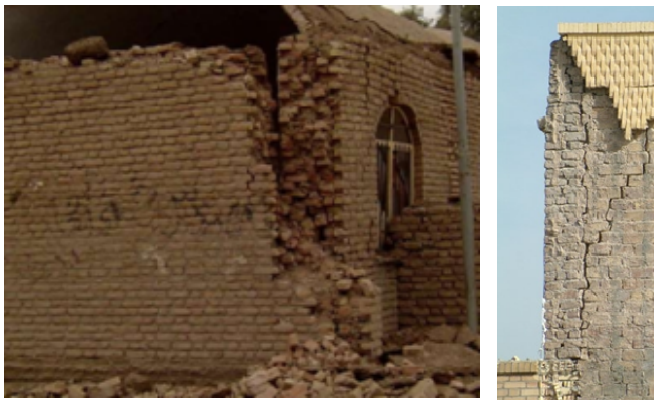
**Fig. 11.** Vulnerable wall-to-wall connection failed in Bam earthquake, Iran 2000

To investigate the effect of the strengthening method used in this paper on the wall-to-wall connection, which was one of the failure modes in some earthquakes shown in Figure 11, it was decided to model the wall-to-wall connection in numerical analysis and quantifying the strengthening effect on the torsional capacity of brick buildings.
